## Flammability of Automotive Child Restraint Seats for Use in Aircraft

November 2001

DOT/FAA/AR-TN01/42

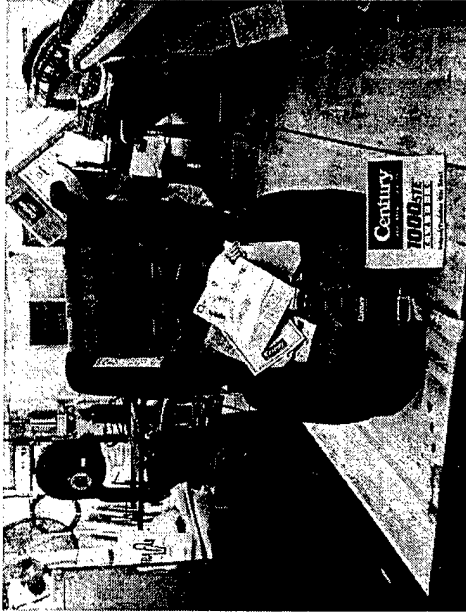
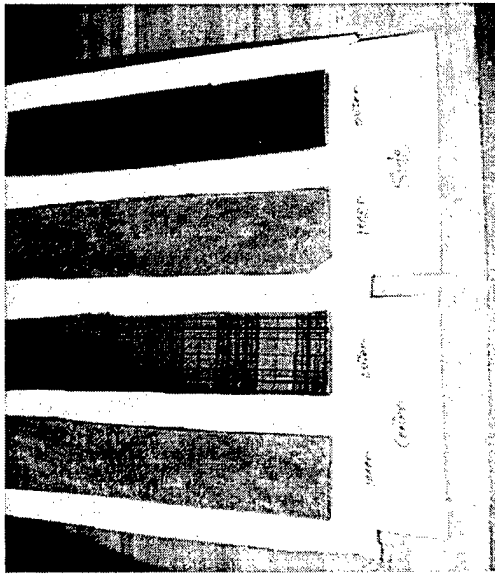
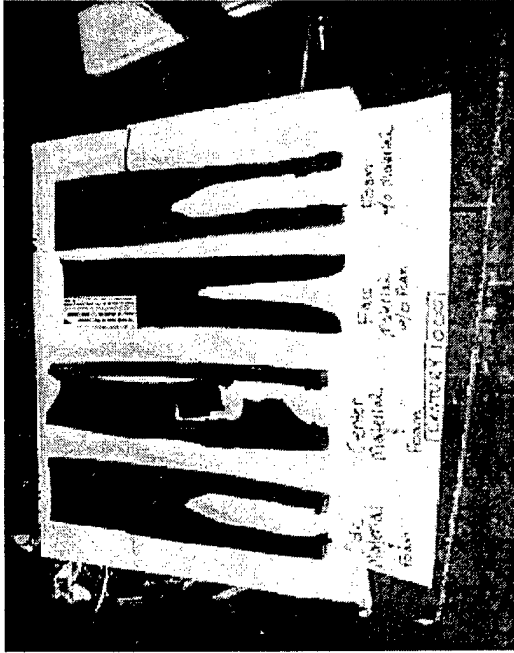
FIGURE 1. CENTURY 1000 STE: \$49.00

- Century 1000 STE. Four of the six seat materials failed the vertical test criteria (figure 1). The center (checked) material was the most flammable, failing both flame time and burn length criteria (entire sample length was burned). Even those materials that passed had relatively long burn lengths (>5 inches).

Material Name	Time to Ignition (min:sec)	Flame Time (min:sec)	Burn Length (inches)	Drip Flame Time (min:sec)	Comments
Sides (blue)	0:01	0:14	Face: 7.0 Back: 7.8	0:00	Fail
Sides (blue)	0:01	0:30	Face: 7.4 Back: 10.0	0:00	Fail
Sides (blue)	0:01	0:02	Face: 5.6 Back: 6.5	0:00	Fail
Center (checked)	0:01	1:23	12.0+	0:00	Fail
Center (checked)	0:01	1:21	12.0+	0:00	Fail
Cloth Face (no foam)	0:01	0:00	Withdrew 5.8	0:00	Pass
Foam Alone (w/o cloth face)	0:01	0:12	10.0	0:00	Fail
Plastic Structure	0:01	2:18	7.5	0:30	Fail
Foam Backing	0:01	0:04	5.75	0:00	Pass

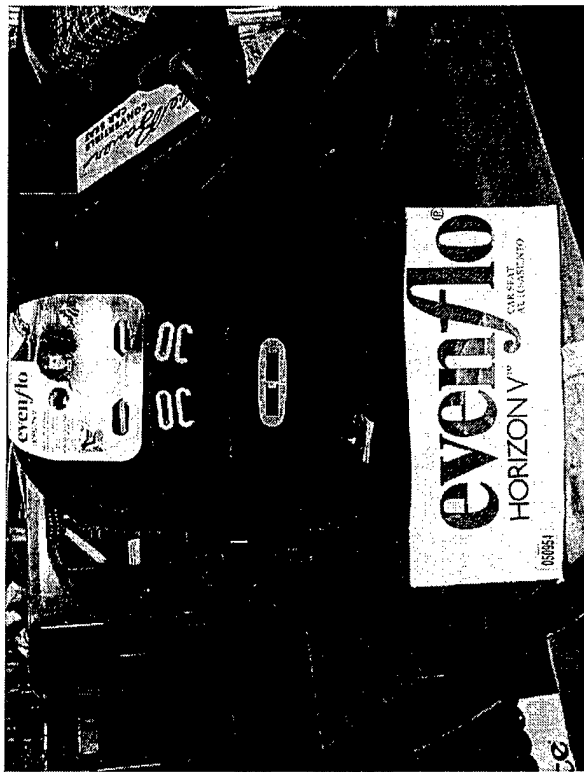
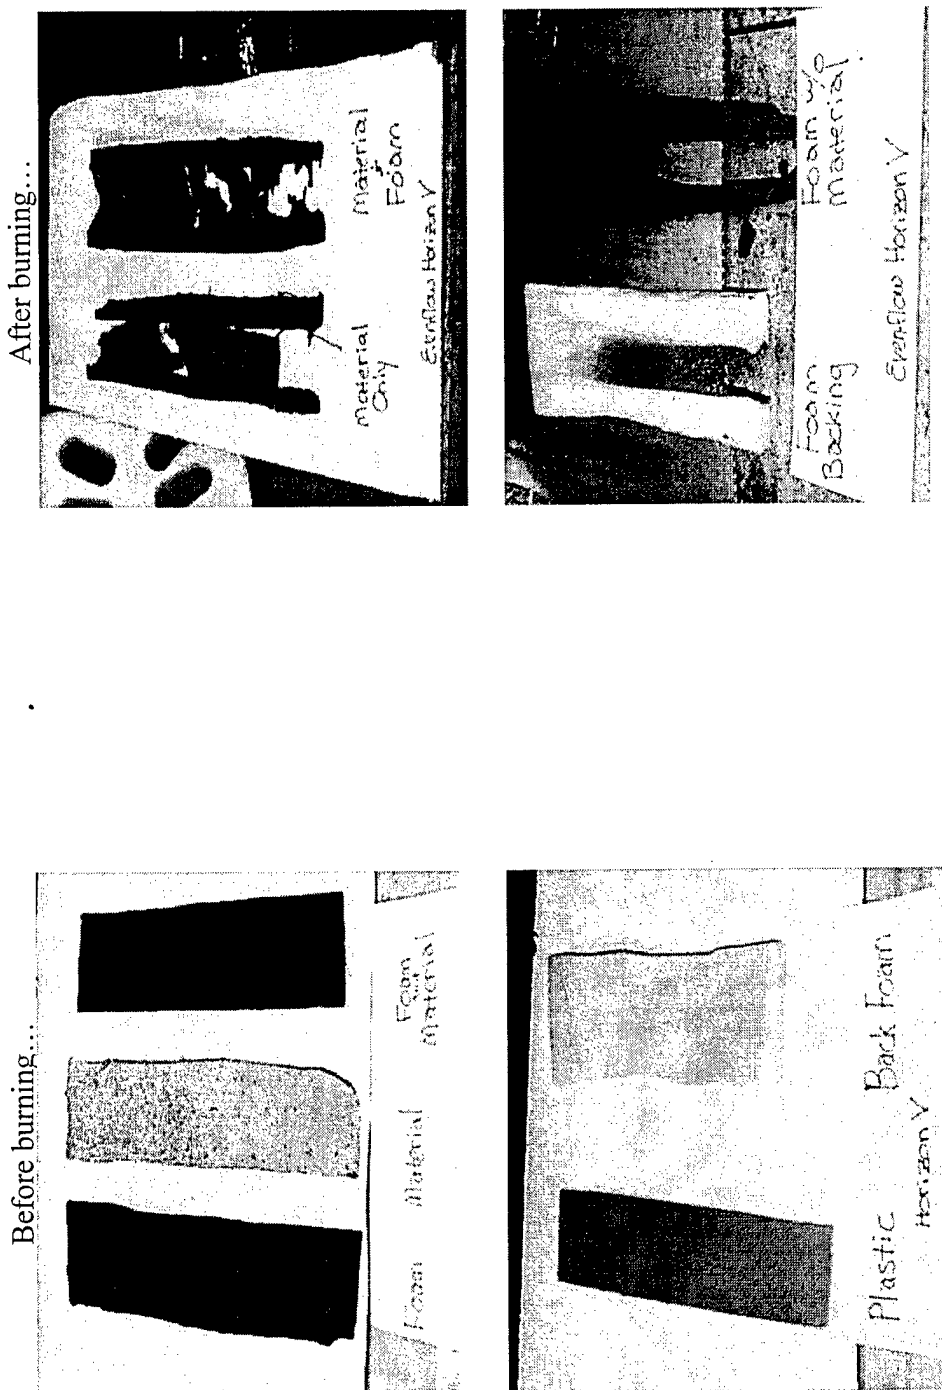
FIGURE 2. EVENFLO HORIZON V: \$79.99

- Evenflo Horizon V. Four of the five seat materials failed the vertical test criteria (figure 2). Three of the failed materials exceeded both the allowable flame time and burn length (entire sample length was burned).

Material Name	Time to Ignition (min:sec)	Flame Time (min:sec)	Burn Length (inches)	Drip Flame Time (min:sec)	Comments
Outer Material (entire seat)	0:01	1:10	12.0+	0:00	Fail
Outer Material (entire seat)	0:01	1:16	12.0+	0:00	Fail
Outer Material (entire seat)	0:01	1:12	12.0+	0:00	Fail
Cloth Face	0:01	0:53	12.0+	0:00	Fail
Plastic Structure	0:01	7:10	12.0	0:00	Fail
Foam Alone (w/o face)	0:01	0:00	9.0	0:00	Fail
Foam Backing	0:01	0:00	6.0+	0:00	Pass

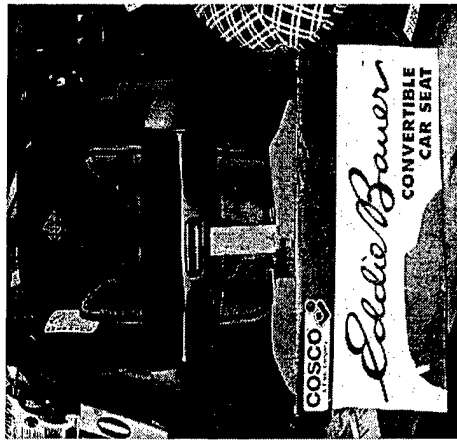
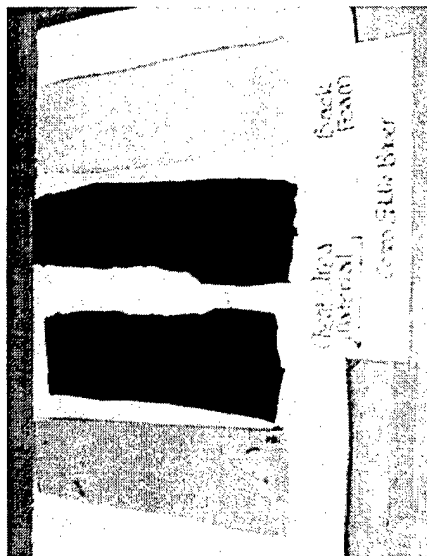
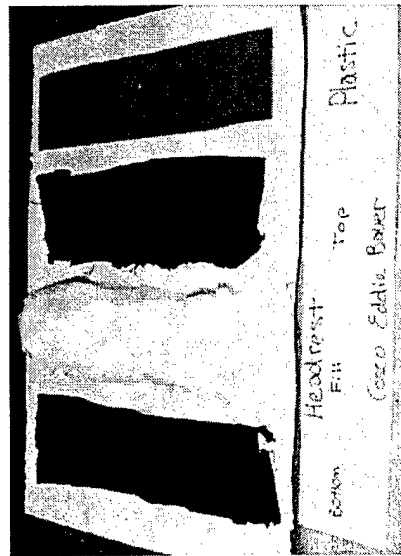
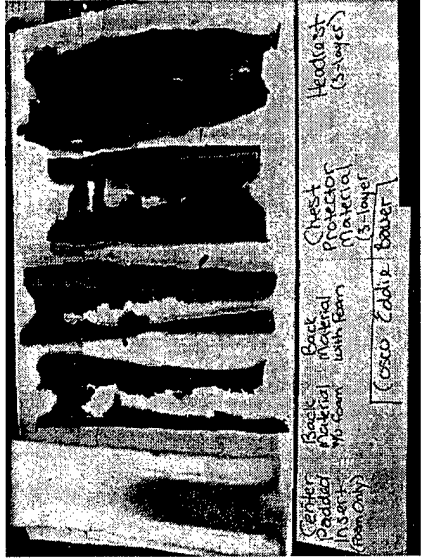
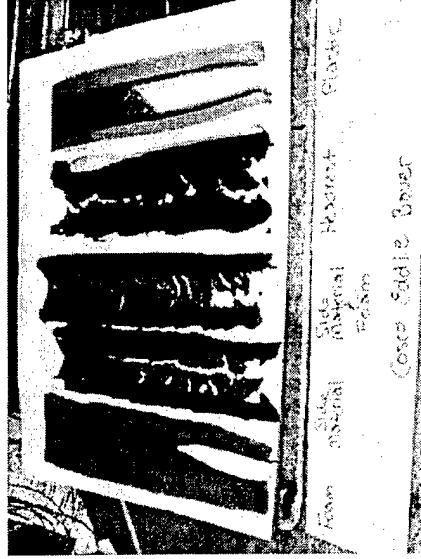
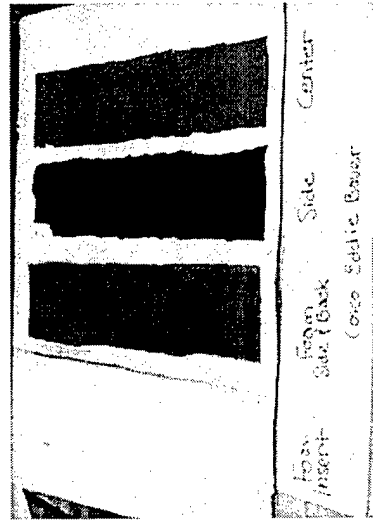
FIGURE 3. COSCO EDDIE BAUER: \$99.99

- Cosco Eddie Bauer. Seven of the eight materials failed the vertical test criteria (figure 3). All of the samples that failed exhibited very high flames. The center-padded insert foam, which passed, was the only material that did not exhibit high flames. One specimen of fabric material was tested in accordance with the FMVSS test procedure (horizontal orientation). A burn rate of 3.8 inches/minute was measured, just slightly less than the allowable 4.0-inches/minute value.

Material Name	Time to Ignition (min:sec)	Flame Time (min:sec)	Burn Length (inches)	Drip Flame Time (min:sec)	Comments
Foam with Green Material	0:01	1:15	12.0+	0:00	Very High Flames (10-12 in), Fail
Green Material Only	0:01	0:57	12.0+	0:00	Very High Flames, Fail
Foam w/o Green Material	0:01	0:00	Front: 6.0, Back: 6.5	0:00	Pass
Headrest (3-layer)	0:01	1:16	12.0+	0:00	Very High Flames, Fail
Headrest (3-layer)	0:01	1:13	12.0+	0:00	Very High Flames, Fail
Plastic Structure	0:04-0:05	2:18	9.0	1:00	Fail
Center Padded Insert Material (brown)	0:01	0:58	12.0	0:00	Very High Flames, Fail
Center Padded Insert Material (brown)	0:01	0:57	12.0+	0:00	Very High Flames, Fail
Back Material and Foam	0:01	1:50	12.0+	0:00	Very High Flames, Fail
Center Padded Insert Foam Only	0:01	0:01	Front: 5.5, Back: 4.5	0:00	Pass
Chest Protector	0:01	1:08	12.0+	0:00	Very High Flames, Fail

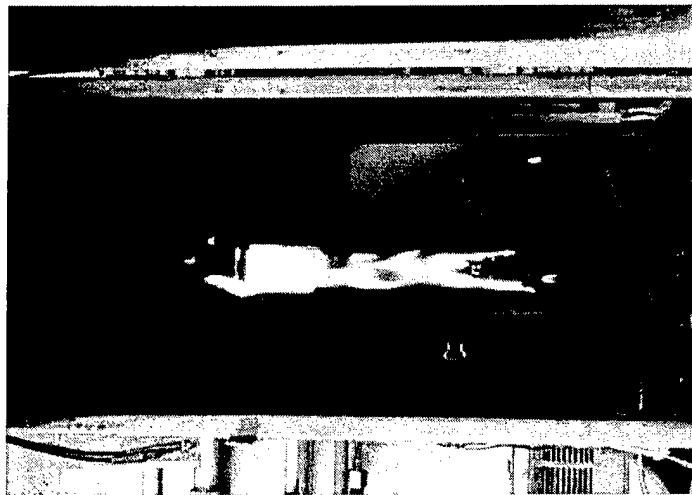
Green Outer Seat Material

NOTE: The Eddie Bauer seat materials had substantially higher flames than the other seven seats in the test. To show the magnitude of these flames, here are pictures of the Eddie Bauer seat during actual testing.

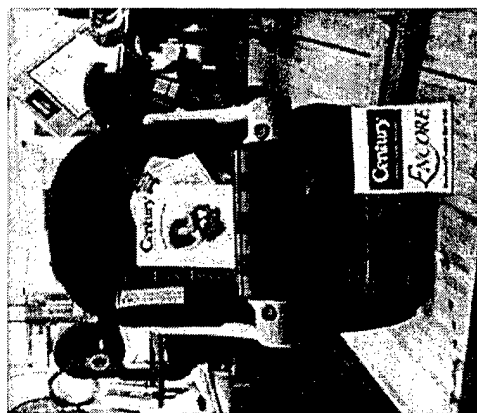
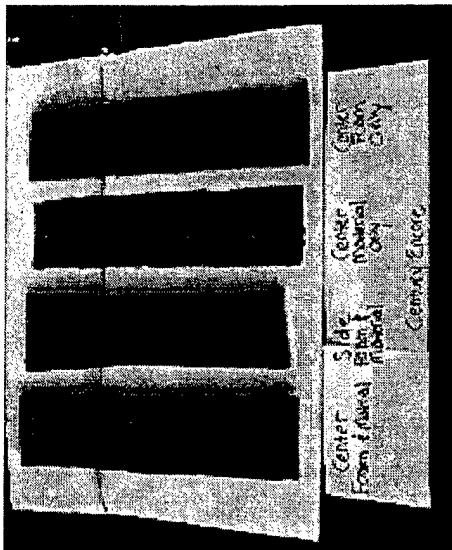
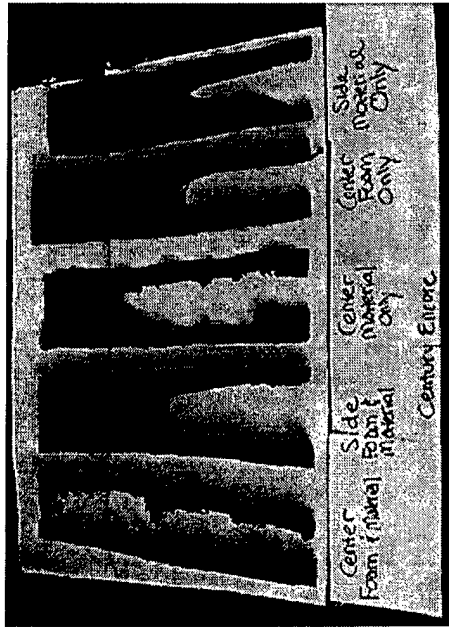
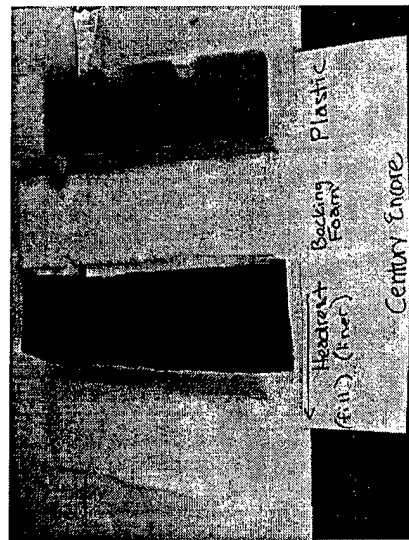
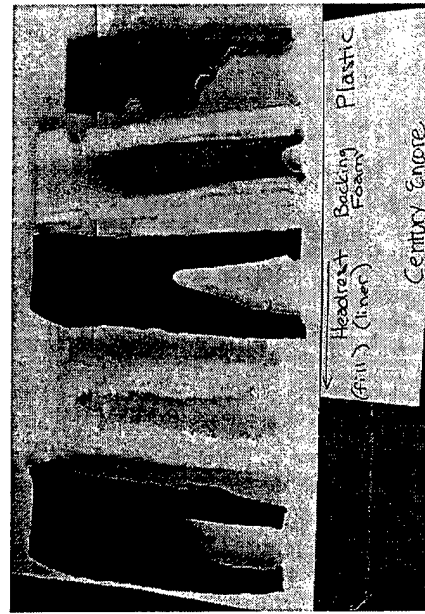
FIGURE 4. CENTURY ENCORE: \$89.00

- Century Encore. Four of the nine seat materials failed the vertical test criteria (figure 4). Some of the materials generated heavy smoke, including two of the samples that passed the test criteria. Again, even those samples that passed had relatively long burn lengths (>5 inches).

Material Name	Time to Ignition (min:sec)	Flame Time (min:sec)	Burn Length (inches)	Drip Flame Time (min:sec)	Comments
Center Foam and Material (plaid)	0:01	1:23	12.0+	0:21	Heavy Smoke, Fail
Side Foam and Material (blue)	0:01	0:05	Front: 7.0 Back: 6.8	0:00	Heavy Smoke, Fail
Side Foam and Material (blue)	0:01	0:12	Front: 8.2 Back: 10.5	0:00	Heavy Smoke, Fail
Center Material Only (plaid)	0:01	1:06	8.5	0:00	Heavy Smoke, Fail
Side Material Only (blue)	0:01	0:05	Withdrew 5.6	0:00	Pass
Center Foam Only	0:01	0:06	8.0	0:00	Pass
Center Foam Only	0:01	0:03	Front: 7.0 Back: 8.0	0:00	Pass
Foam Backing	0:01	0:00	6.5	0:00	Pass
Headrest (3-layer)	0:01	0:08	Front: 4.75 Back: 5.2	0:00	Heavy Smoke, Pass
Headrest Liner	0:01	0:05	Withdrew 5.8	0:00	Heavy Smoke, Pass
Headrest Fill	0:01	0:00	Withdrew 9.0	0:00	Withdrew w/no flame, Fail
Plastic Structure	0:01	1:58	5.0	1:30	Fail

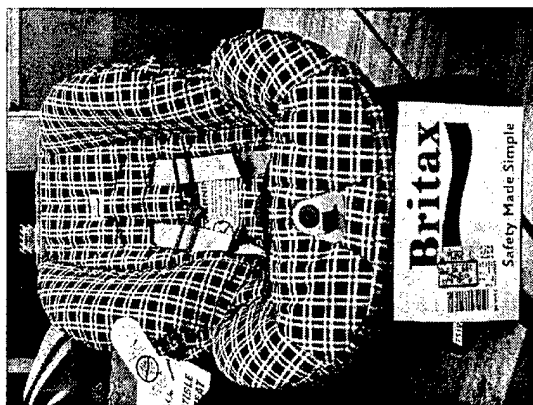
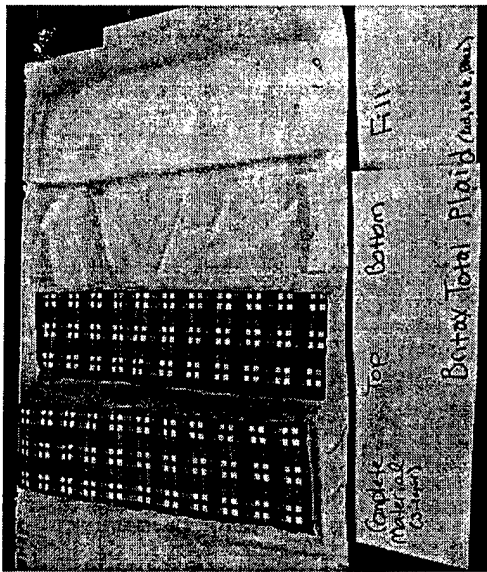
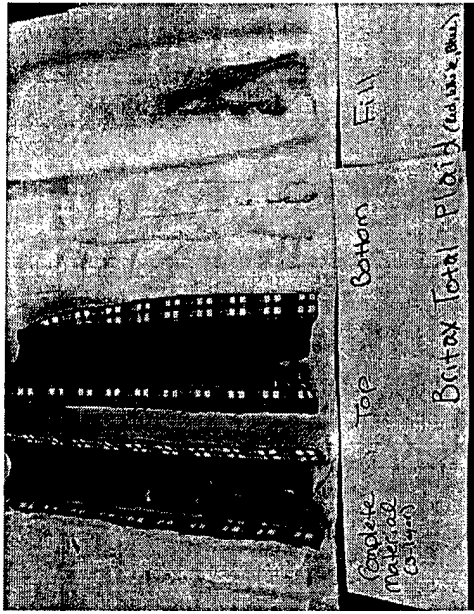
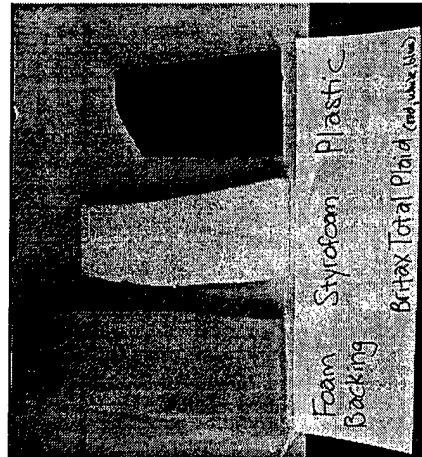
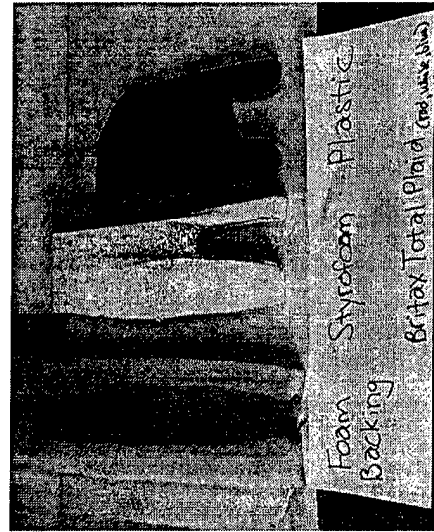
FIGURE 5. BRITAX TOTAL PLAID: \$199.99

- Britax (Total Plaid). Four of the seven seat materials failed the vertical test criteria (figure 5). Some of the materials, including a sample that passed, exhibited heavy smoke and, in one case, fast burning. The two materials that passed had relatively long burn lengths (>5 inches).

Material Name	Time to Ignition (min:sec)	Flame Time (min:sec)	Burn Length (inches)	Drip Flame Time (min:sec)	Comments
Complete Material (3-layer)	0:01	0:55	12.0+	0:00	Heavy Smoke, Fail
Top Material	0:01	0:14	12.0+	0:00	Fast Burning, Fail
Bottom Material	0:01	0:00	Withdrew 9.0	0:00	Heavy Smoke, Fail
Fill Material	0:01	0:00	Withdrew 5.5	0:00	Heavy Smoke, Pass
Foam Backing	0:01	0:00	6.9	0:00	Pass
Styrofoam	0:01	0:00	Withdrew 8.0	0:00	Pass
Plastic Structure	0:01	2:31	4.7	1:37	Fail

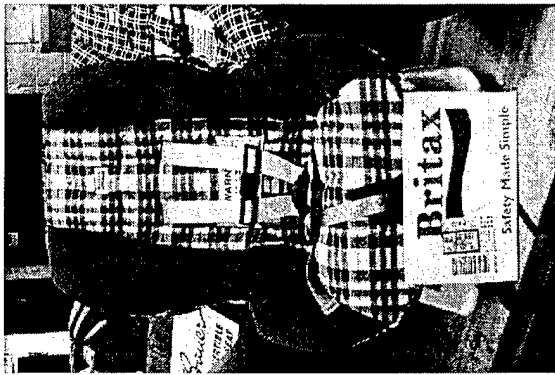
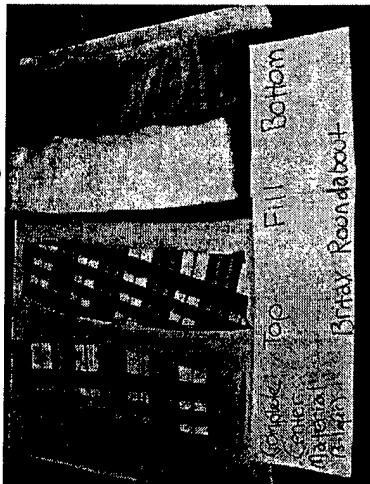
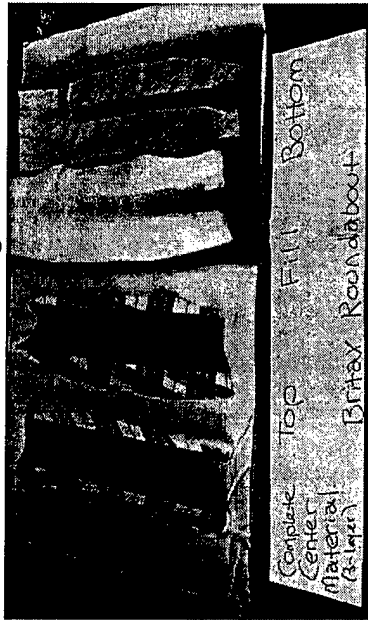
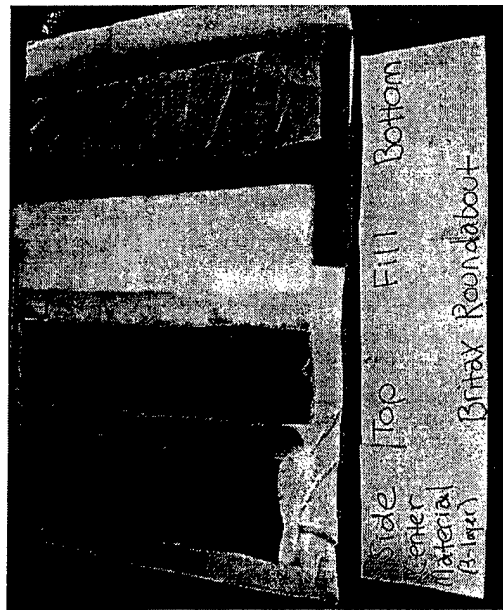
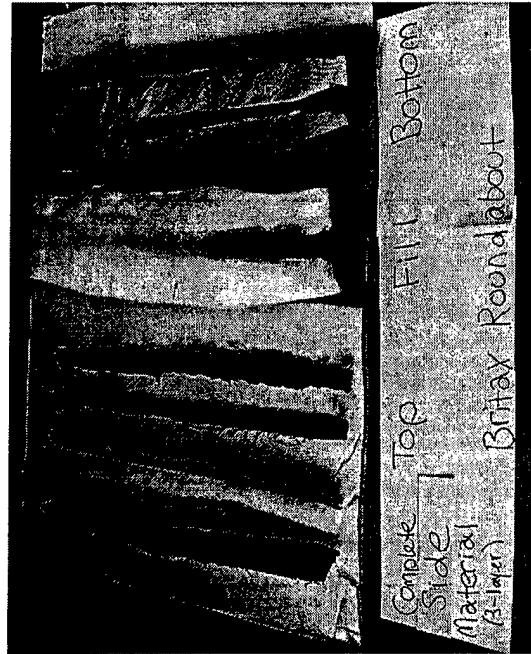
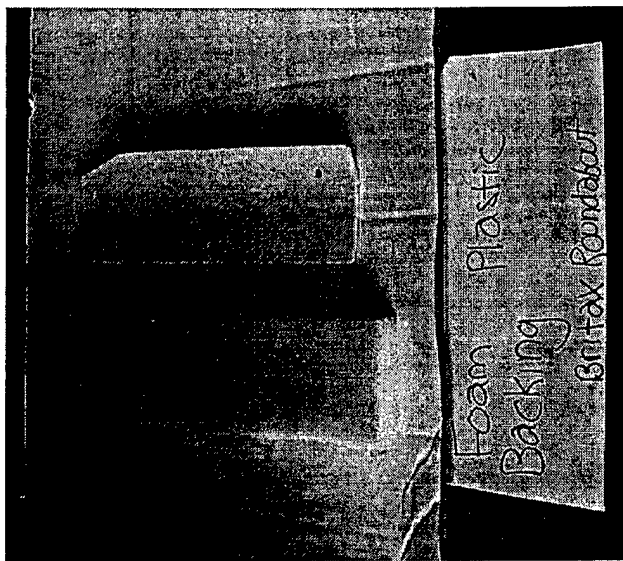
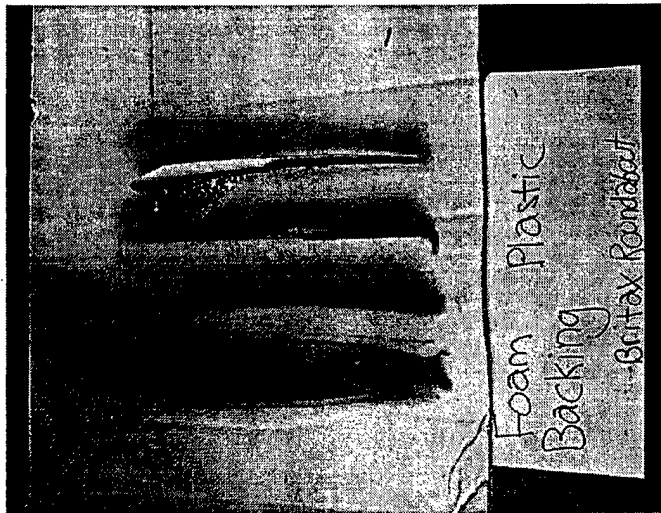
FIGURE 6. BRITAX ROUNDABOUT: \$199.00

- Britax Roundabout. Six of the eight seat materials failed the vertical test criteria (figure 6). Those materials that passed had relatively long burn lengths (7 and 8 inches). Four of the materials burned along the entire sample length.

Material Name	Time to Ignition (min:sec)	Flame Time (min:sec)	Burn Length (inches)	Drip Flame Time (min:sec)	Comments
Complete Center Material	0:01	0:48	12.0+	0:00	Fail
Top Material (plaid)	0:01	0:37	12.0+	0:00	Fail
Fill Material	0:01	0:00	8.0	0:00	Pass
Bottom Material	0:01	0:00	9.3	0:00	Fail
Complete Side Material	0:01	1:20	12.0+	0:00	Fail
Top Material (denim)	0:01	1:01	12.0+	0:00	After flame out, material continued to glow - only occurrence of this throughout the test. Fail
Fill Material	Same material as 4 lines above—same material should produce similar results				
Bottom Material	Same material as 5 lines above—same material should produce similar results				
Backing Foam	0:01	0:01	7.0	0:00	Pass
Plastic Structure	0:01	2:35	8.5	0:25	Fail

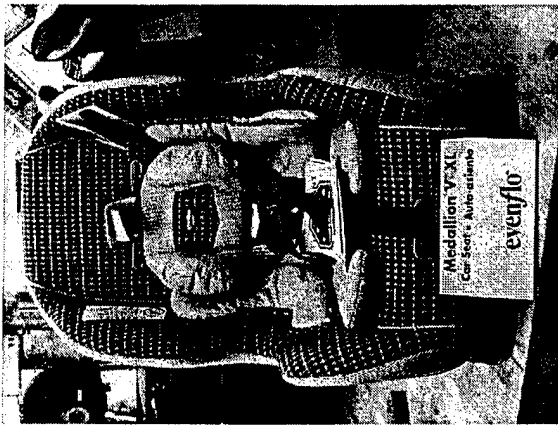
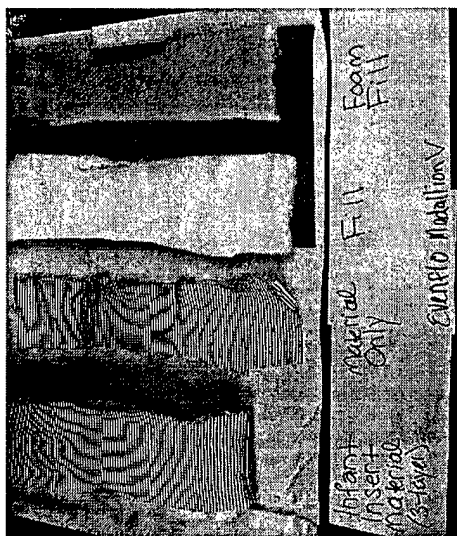
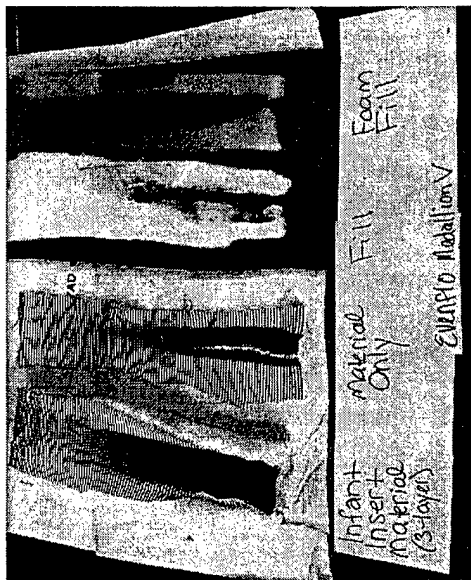
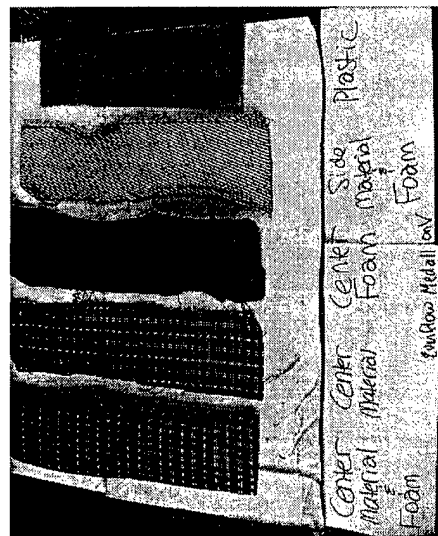
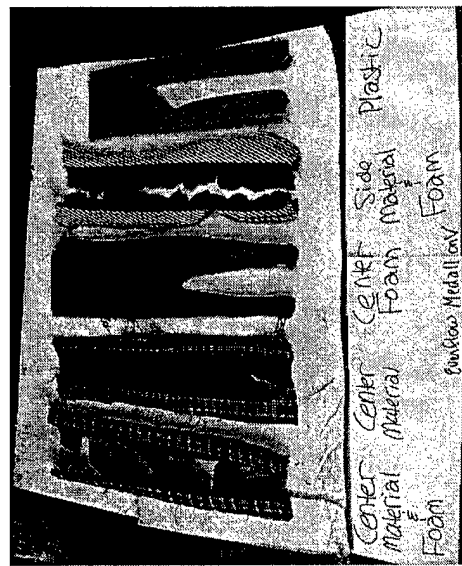
FIGURE 7. EVENFLO MEDALLION V: \$139.99

- Evenflow Medallion. Six of the nine seat materials failed the vertical test criteria (figure 7). The center material and foam produced the heaviest smoke of all seat materials in the

test series. It appeared that the dense smoke inside the test chamber was the cause of flame extinguishment. When it appeared that the flame was out and the door of the test cabinet was slightly opened to evacuate the smoke, the flame reignited apparently due to oxygen entering the cabinet.

Material Name	Time to Ignition (min:sec)	Flame Time (min:sec)	Burn Length (inches)	Drip Flame Time (min:sec)	Comments
Infant Insert Material (3-layer)	0:01	1:06	4.8	0:00	Fail
Infant Insert Material (3-layer)	0:01	0:01	3.5	0:00	Fail
Top Material	0:01	0:00	6.25	0:00	Pass
Fill Material	0:01	0:14	6.0	0:00	Pass
Foam Fill	0:01	0:00	7.8	0:00	Pass
Center Material and Foam	0:01	1:00	12.0+	0:00	Heaviest Smoke, Fail
Center Material and Foam	0:01	1:04	12.0+	0:00	Heaviest Smoke, Fail
Center Material	0:01	0:11	12.0+	0:00	Fail
Center Foam	0:01	0:17	7.1	0:00	Fail
Side Material and Foam	0:01	0:21	12.0+	0:00	Heaviest Smoke, Fail
Plastic Structure	0:05	3:56	8.5	2:00	Fail
Backing Foam	Same material as Evenflo Horizon V Backing Foam—should produce similar results

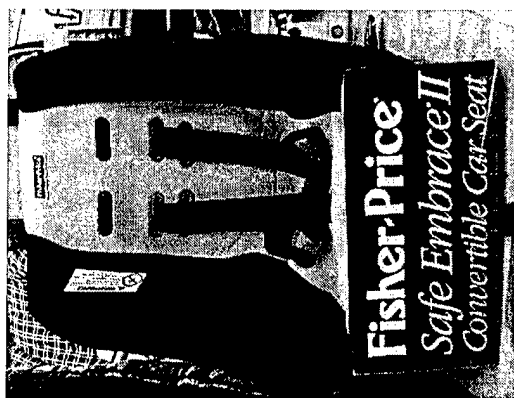
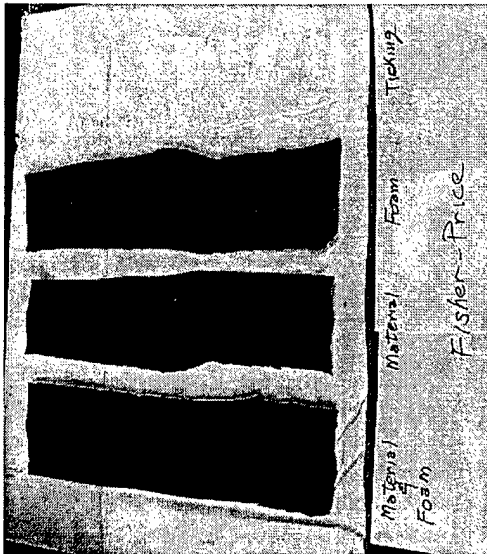
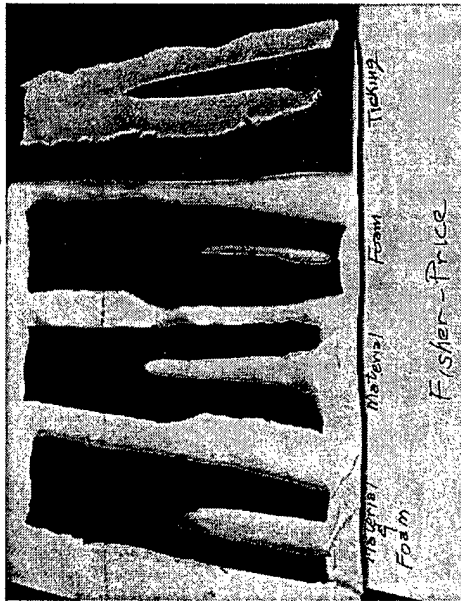
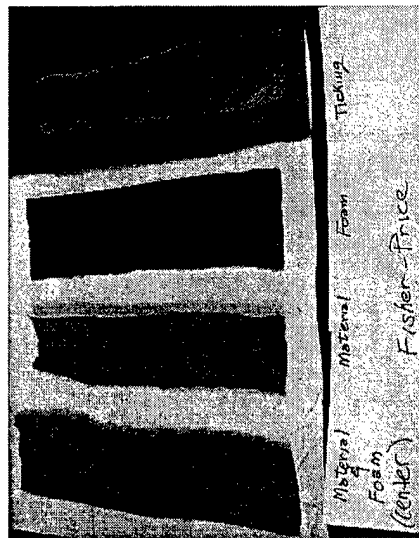
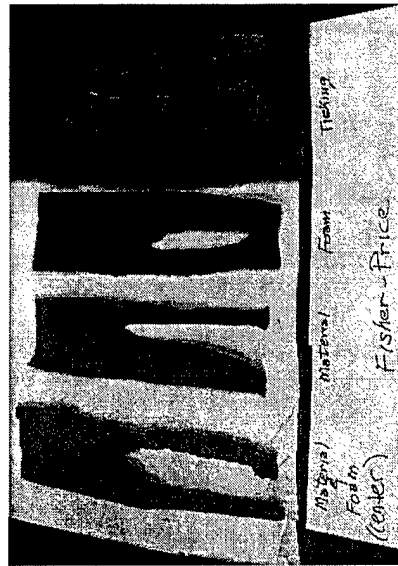
FIGURE 8. FISHER PRICE SAFE EMBRACE II: \$149.99

- Fisher Price Safe Embrace II. Three of the nine seat materials failed the vertical test criteria (figure 8). The materials that passed had relatively long burn lengths ( $\geq 5$  inches).

Material Name	Time to Ignition (min:sec)	Flame Time (min:sec)	Burn Length (inches)	Drip Flame Time (min:sec)	Comments
Side Material and Foam	0:01	0:04	6.3	0:00	Pass
Side Material	0:01	0:00	Withdrew 7.0	0:00	Withdrew w/no flame, Pass
Side Foam	0:01	0:00	5.0	0:00	Pass
Bottom Material	0:01	0:00	Withdrew 8.0	0:00	Pass
Center Material and Foam	0:01	0:16	Front: 7.0 Back: 9.0	0:00	Fail
Center Material	0:01	0:00	Withdrew 6.5	0:00	Pass
Center Foam	0:01	0:00	Front: 6.5 Back: 8.0	0:00	Pass
Bottom Material	0:01	0:00	Withdrew 11.0	0:00	Fail
Backing Foam	Same material as Britax Total Plaid Backing Foam—should produce similar results				
Plastic	0:05	2:43	9.0	0:22	Fail
